*International Award Lecture,
10th Int. Conf. of European Ceramic Society,
Berlin, Germany, June 17-21, 2007*

**In-Space Repair and Refurbishment of Thermal Protection System
Structures of Reusable Launch Vehicles**

M. Singh
Ohio Aerospace Institute
NASA Glenn Research Center
Cleveland, OH 44135 (USA)

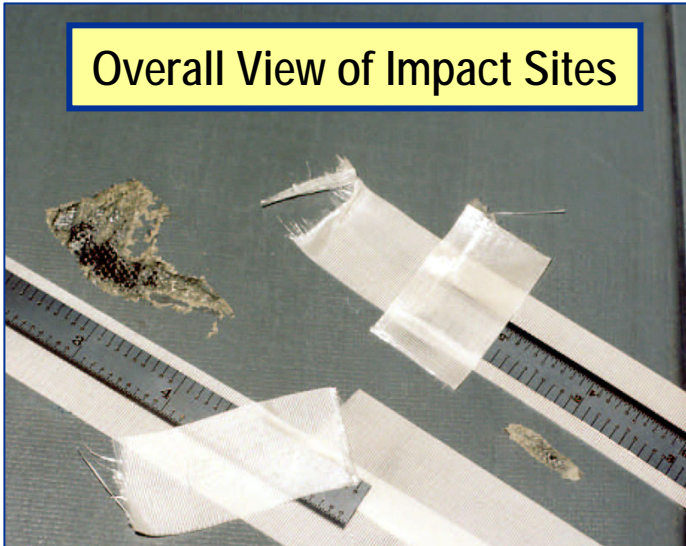
Overall View of Impact Sites

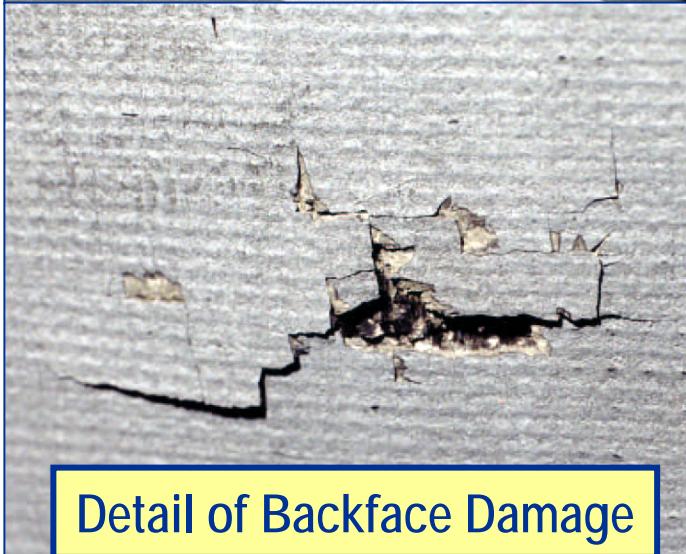
Detail of Backface Damage

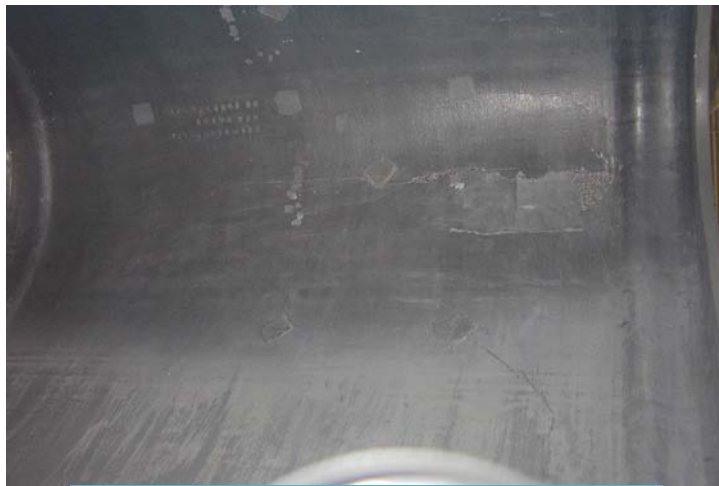
IML Damage Surface Panel 9L

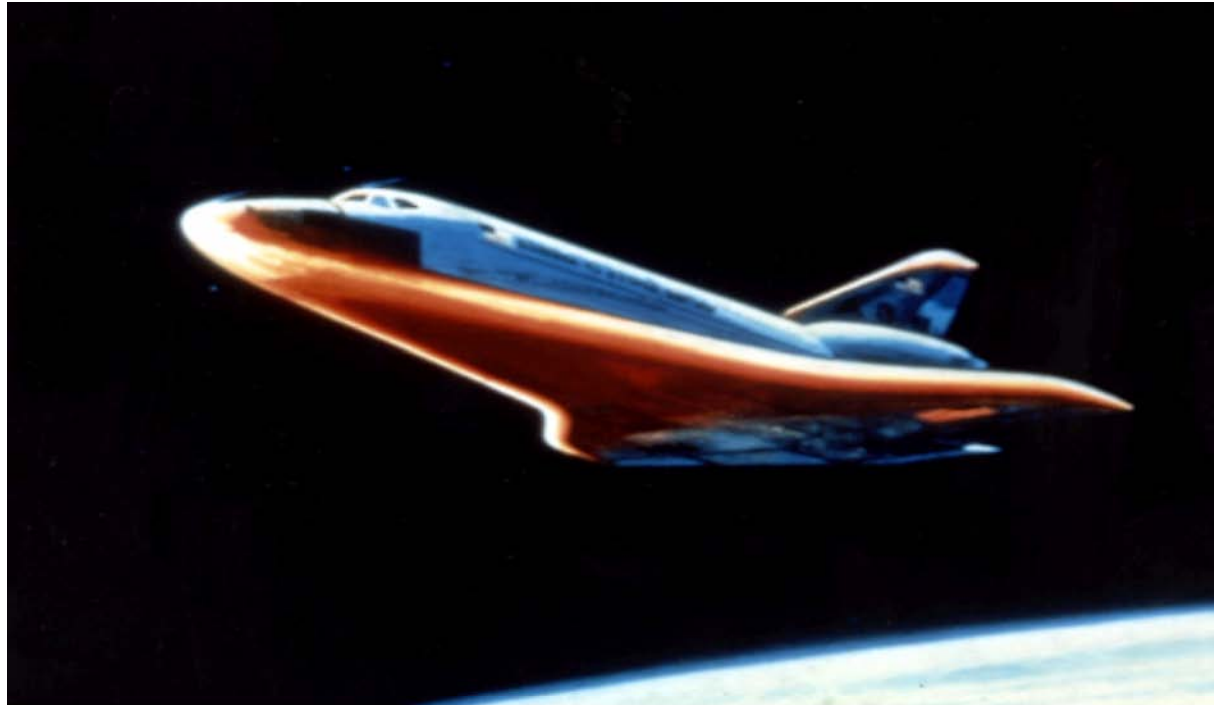
Space Shuttle Re-entry Conditions are Quite Harsh and Extreme

- Temperature to 2000 K
- Reduced pressure--0.005 to 0.010 atm
- Gases--O₂, N₂, CO₂
 - Shock leads to O, N and ions
- Short times ~15 minutes/re-entry
- Best simulated with arc-jet

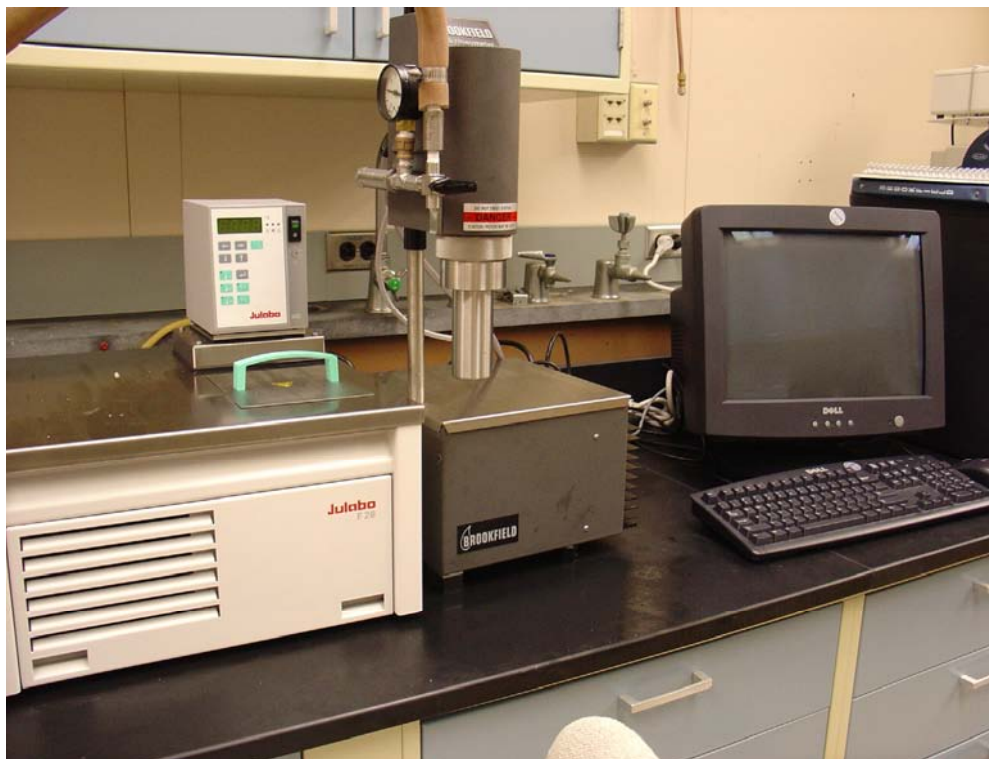
Brookfield PVS Rheometer Used for the Viscosity Measurements

*The temperature control bath has capability from
– 20 C (- 4 F) to 180 C (356 F)*

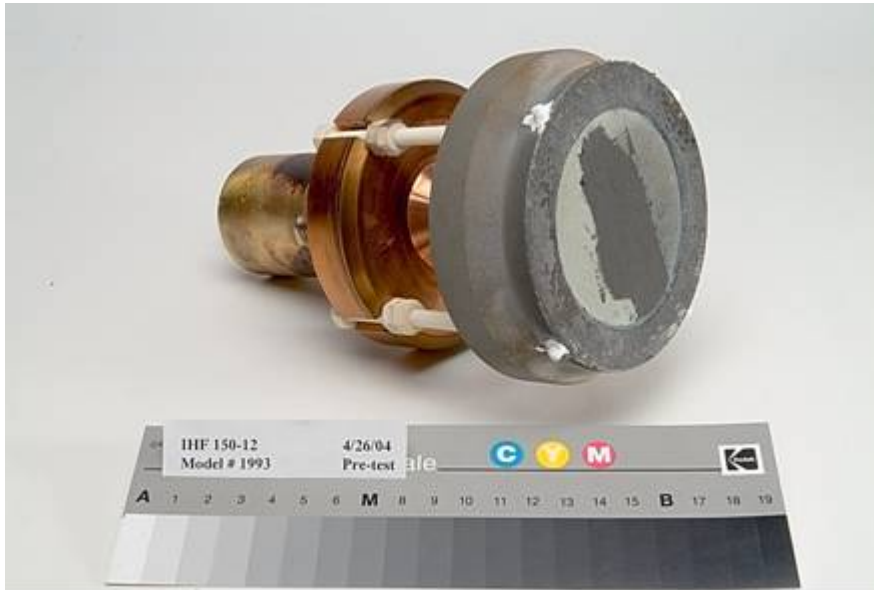
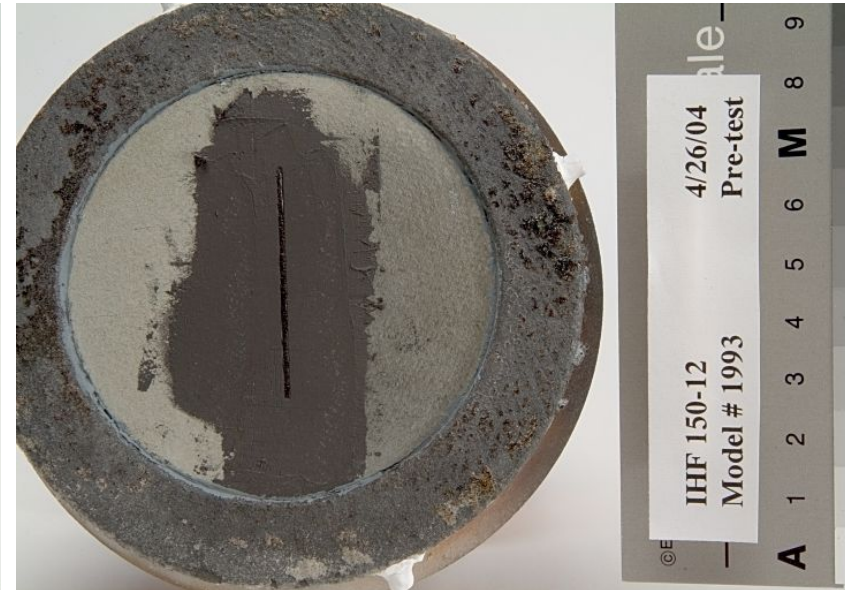
Pre-Test Photographs of Repaired Specimens

Run 12 – Model 1993

(0.035" or ~0.89 mm wide crack, GRABER-5A)

Percent Argon = 6% @ 2960F condition

Add air = 11.6% @ 2960F condition

Anomaly: water leak from electrode, which allowed water vapor in the stream

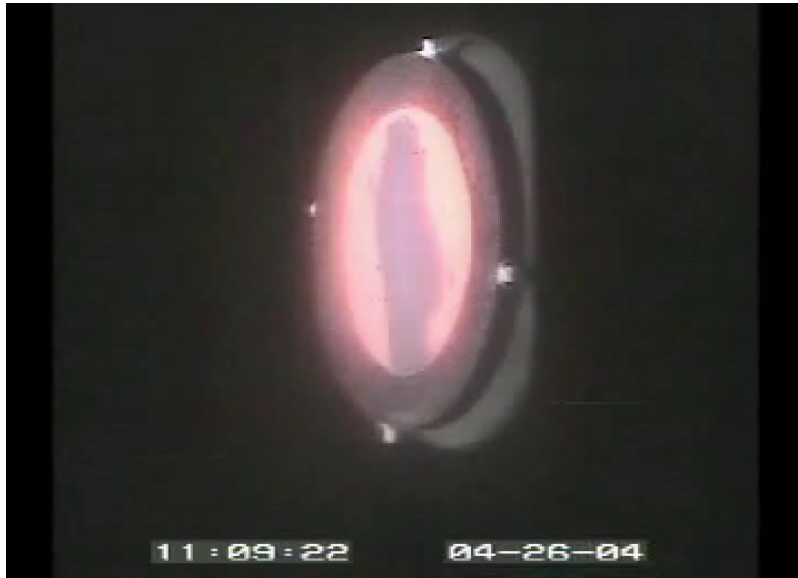
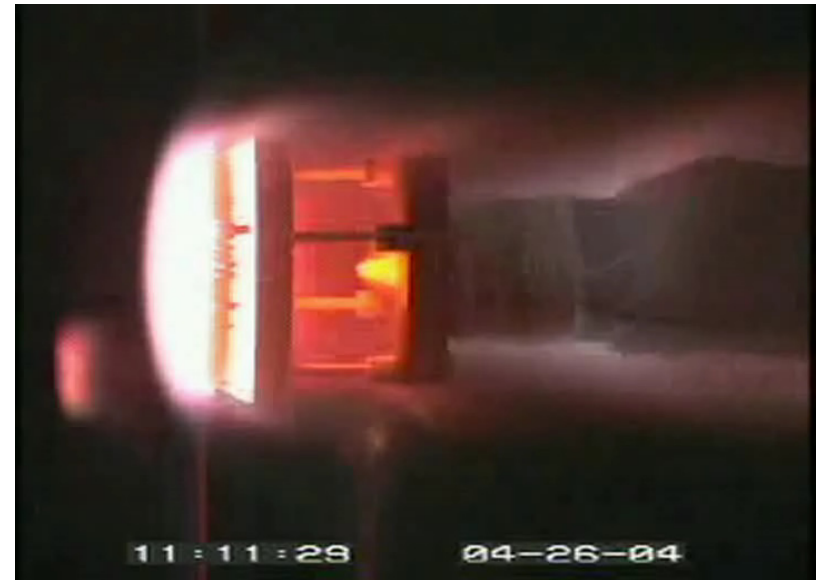
Run 12 – Model 1993

ArcJet Testing of Repaired Specimens

(0.035" or ~0.89 mm wide crack, GRABER-5A)

Front View

Side View

Percent Argon = 6% @ 2960F condition

Add air = 11.6% @ 2960F condition

Anomaly: water leak from electrode, which allowed water vapor in the stream

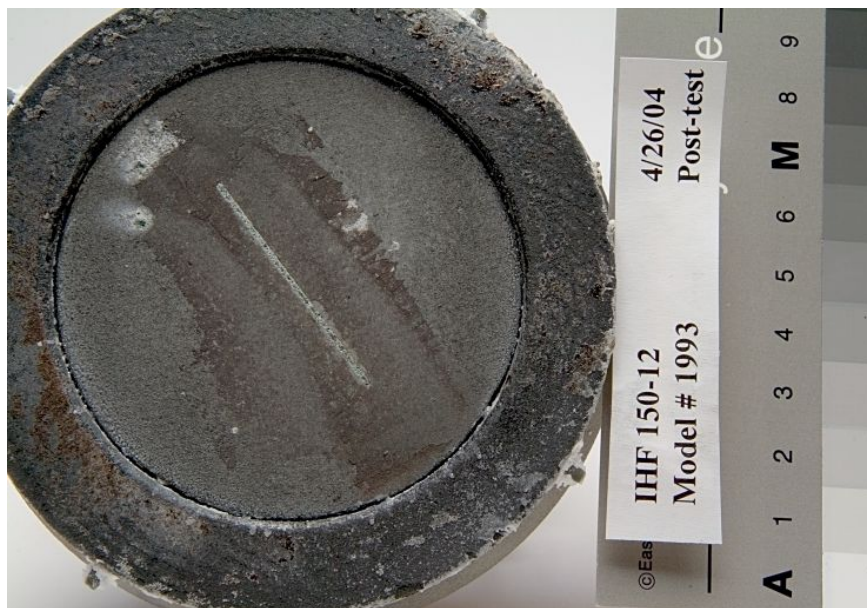
Run 12 – Model 1993

ArcJet Testing of Repaired Specimens

(0.035" or ~0.89 mm wide crack, GRABER-5A)

Post Test- Front Side

Post Test- Back Side

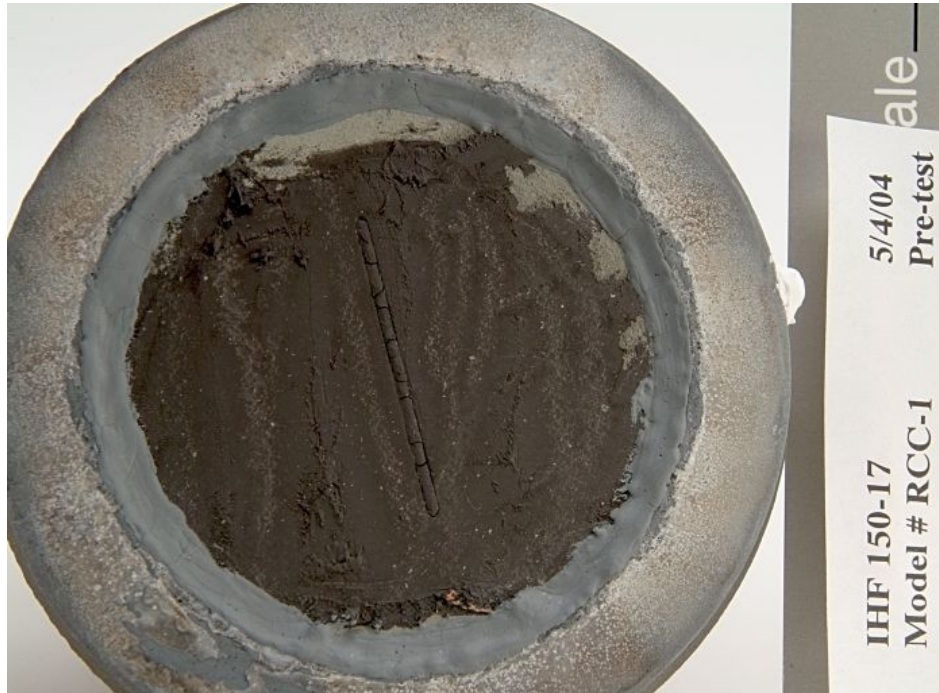
Run 17 – Model RCC 1

ArcJet Testing of Repaired Specimens

(0.062" or ~1.6 mm wide crack, GRABER-5A)

Percent Argon = 6% @ 2960F condition

Add air = 11.6% @ 2960F condition

Anamoly: Edge failure, sample removed after ~130 seconds @ 2960F condition

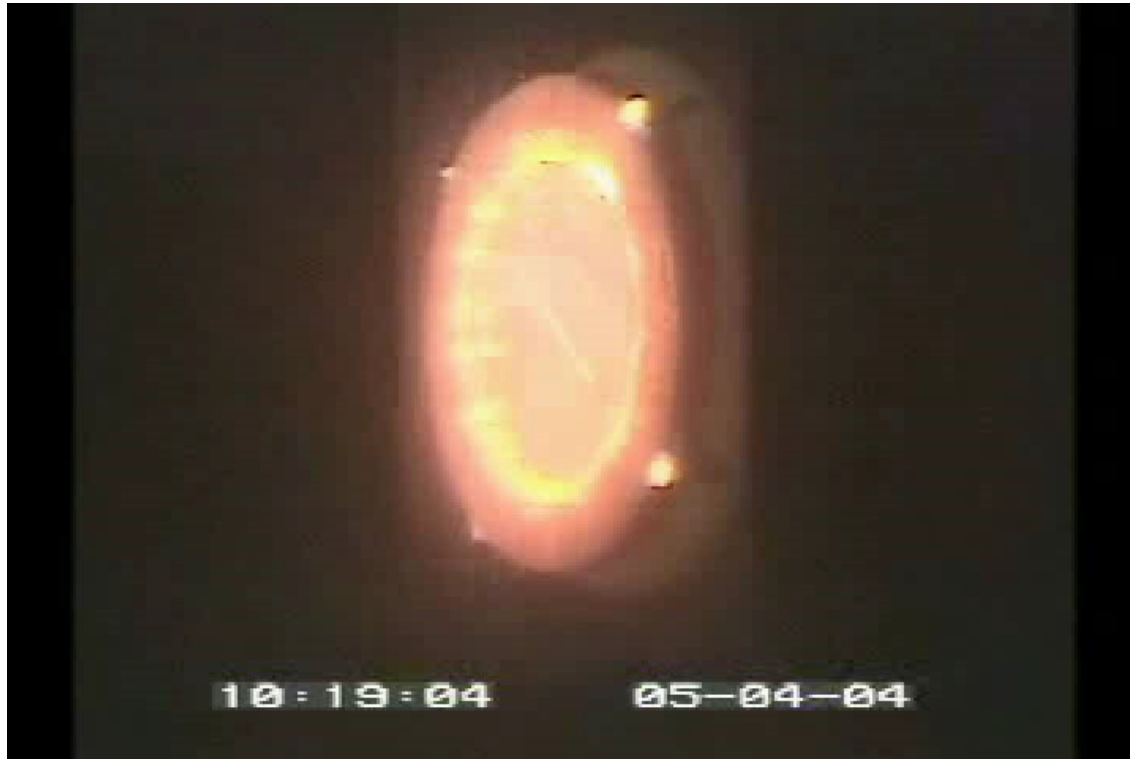
Run 17 – Model RCC 1
(0.062" or ~1.6 mm wide crack, GRABER-5A)

ArcJet Testing of Repaired Specimen

Front View

Percent Argon = 6% @ 2960F condition

Add air = 11.6% @ 2960F condition

Anamoly: Edge failure, sample removed after ~130 seconds @ 2960F condition

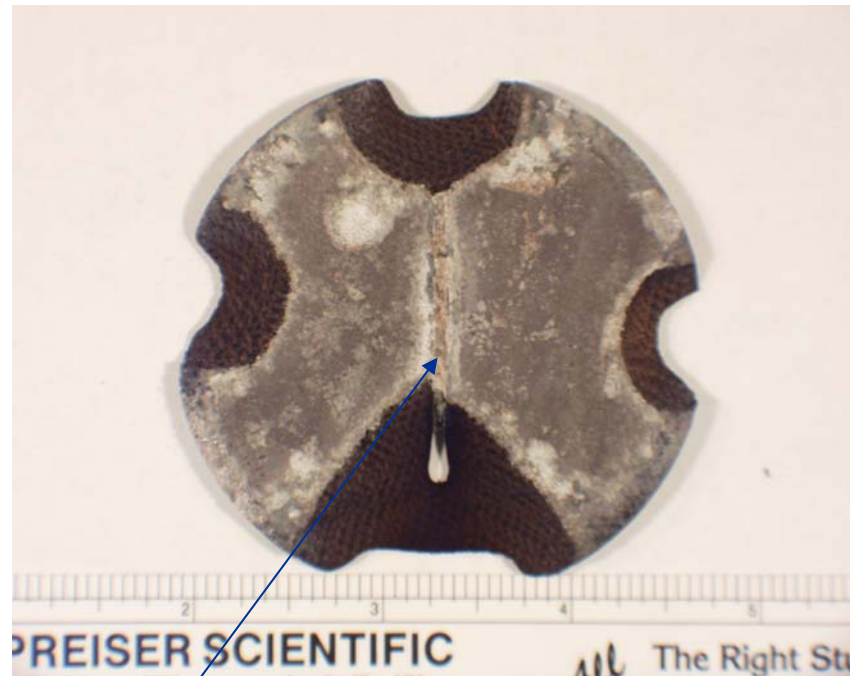
ArcJet Sample 150-11, RCC-1, GRABER 5A, 0.062" Crack Width

Back side

Front side

Crack filled with Graber material

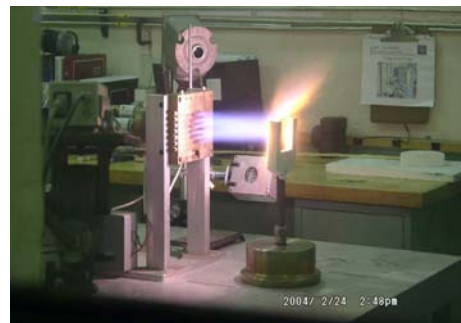
**QARE Rig
Testing (GRC)**

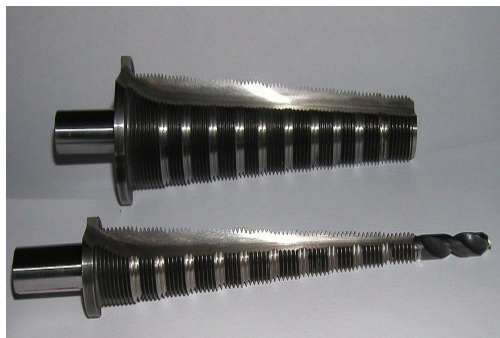
Drill/Tap Tools

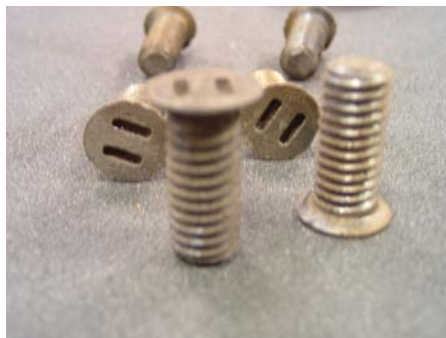
Fasteners

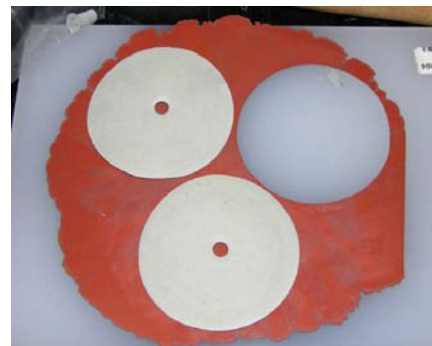
Gaskets

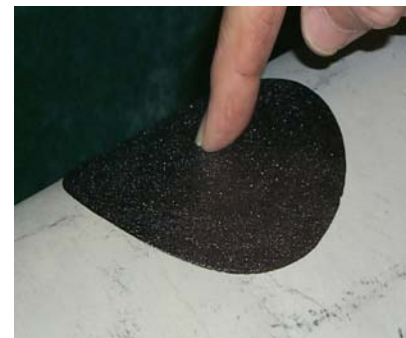
SAR Patch

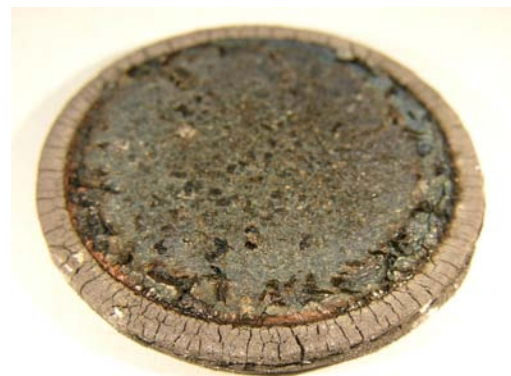
GRC-2 (SiC Fiber)

Tile Test Profile
900 Sec.
Mass loss ~ 19%

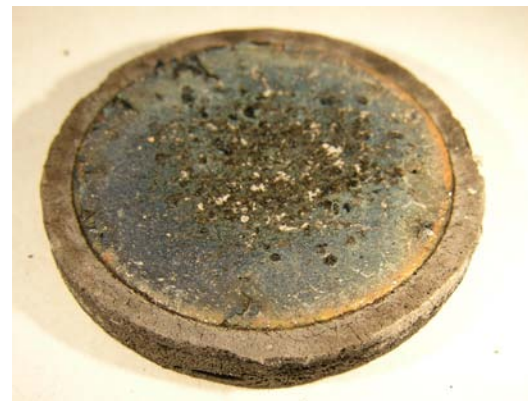
GRC-9 (SiC Fiber)

Tile Test Profile
900 Sec.
Mass loss ~ 17%

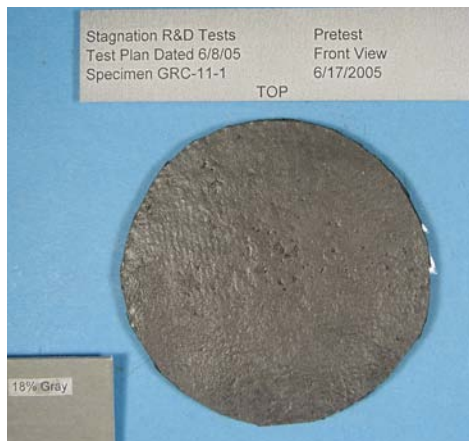
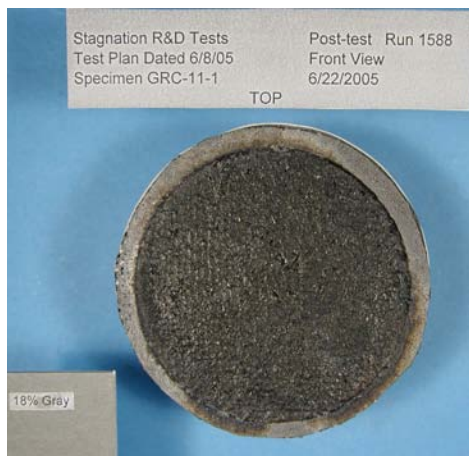
Integrated System for Leading Edge and Tile Repair (InSTALER)

Flexible Ceramic Overwrap

Pre-Test

Post Test
